# **Navajo Abandoned Uranium Mine**

## **Site Screen Report**

### **East Portal, Frank No. 1 Mine AUM Site**

#### **Navajo AUM Northern Region**

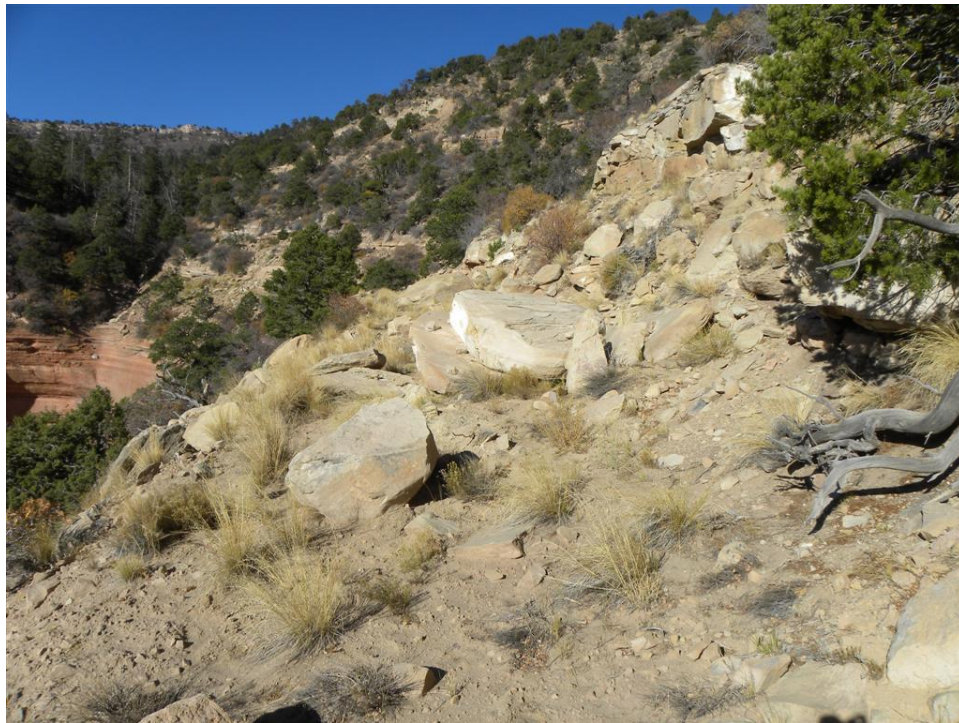
Photo 2. Waste rock

Scattered waste debris along roads throughout site; waste pile along cliff, 500' x 50'; with a total estimated volume of 4,630 yd<sup>3</sup>

Unreclaimed waste pile
